Instituto Politécnico de Setúbal

Mestrado em Segurança e Higiene no Trabalho Projecto Final

Melhoria na Segurança e Higiene no Trabalho Após a Certificação Numa Multinacional

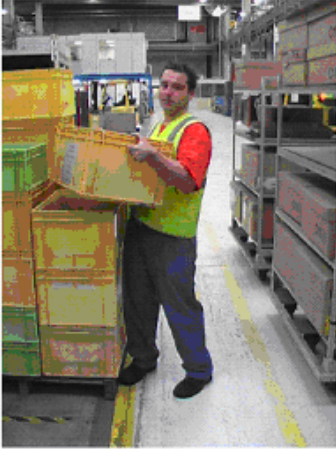
<p>Date: 12/07/2007 Time: 5 pm</p> <p>Description of Work Performed: --- The "little train" driver was handling a plastic box containing metallic pieces for D2 door panel.</p> <p>Description of Incident: - The "little train" driver was handling a plastic box containing metallic pieces when he felt a pain in his back. These metallic pieces are used to avoid D2 door panel . The "little train" driver is responsible of the transfert between assembly line and injection line of D2 door panel of these plastic boxes containing metallic pieces.</p> <p>Injuries: -- Pain on his back – 5 days off</p>	<p>Photo:</p>

<p><u>Key Point Summary</u></p> <ul style="list-style-type: none"> ➤ Weight of the plastic box full of metallic pieces ➤ Volume too high of the plastic box 	<p><u>Key Learning Points</u></p> <ul style="list-style-type: none"> ➤ Used green plastic boxes (lower volume) – NO/GR – S50 ➤ Handling by 2 people the time to put in place the first action – JB – S42

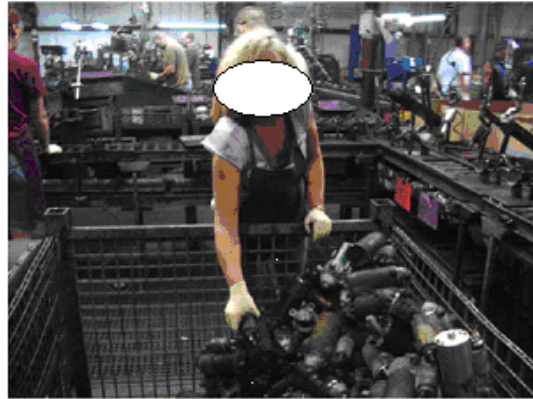
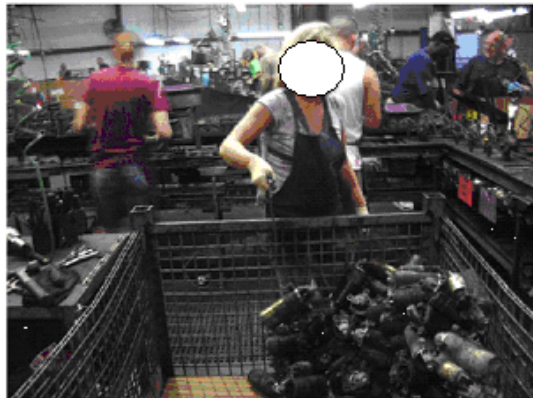
Photo:

- Operation required manual removal of cores from container.
- When parts level in container reached $\frac{1}{2}$ the operator must use extended tool to retrieve parts

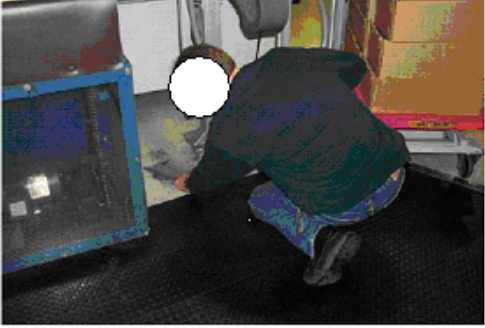
<p><u>Date & Time of Injury:</u> 1/9/08 9:45 PM</p> <p><u>Incident Description:</u> <i>PCM module cover fell off conveyor onto floor. Employee bent down and leaned to side to pick up cover and avoid hitting head on conveyor above. Employee heard a crack in lower back and felt tingling in buttocks. Employee worked rest of shift without incident. Next day he woke up with pain and tingling in buttocks, leg, foot.</i></p> <p><u>additional information:</u></p> <ul style="list-style-type: none"> ➤ <i>witness (Y/N): none</i> ➤ <i>supervisor informed, when: immediate</i> ➤ <i>Flag: first time</i> ➤ Injury Type: herniated disk ➤ Affected Body Part: lower back ➤ Estimated lost days: not yet determined. <p><u>Root Cause</u></p> <p><i>Flag: back injury</i></p> <p><i>Bending/twisting to pickup part may have aggravated a number of pre-existing conditions, such as degenerated disk, herniated, etc. Employee is still undergoing medical evaluations.</i></p> <p><u>Interim Corrective Action:</u> <i>Work area was given reminder on proper lift techniques (lift with legs not back, avoid twisting, etc). Plant safety talk in September 2007 was on back injury prevention.</i></p> <p><u>Permanent Corrective Action</u> <i>Re-emphasis on back injury prevention with upcoming safety talk.</i></p>	<p><u>Photo:</u></p> <p>Photo 1: re-enactment of incident</p>

<p><u>Relevant EH&S Standard</u></p> <ul style="list-style-type: none"> ➤ <u>Standard:</u> <i>Work practices.</i> ➤ <u>Gap to Standard (Y/N):</u> <i>no</i> ➤ <u>Safety Violation (Y/N):</u> <i>no</i> 	<p><u>Key Learning Points</u></p> <ul style="list-style-type: none"> ➤ <i>Minor incidents, even as simple as a sneeze, can cause injuries such as this, especially if there are underlying circumstances. Need to stress following safe work practices all the time regardless of how basic they may be.</i>

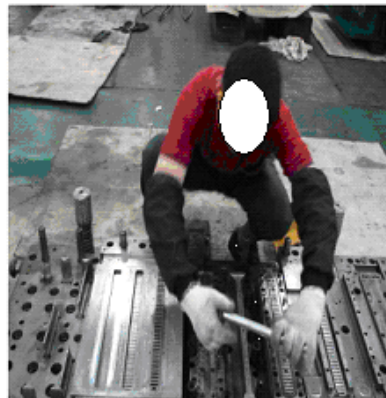
Photo 1:

Musculoskeletal disorder caused by repetition of high force when using the machine tools.
High force was applied employee repeatedly using machine tools (wrench, monkey wrench hammer etc) for repairing press mold.

- ☞ High Force: Employee repeatedly used machine tools (wrench, monkey wrench, hammer, etc.) for repairing press mold.

- ☞ Conduct safety training on the proper use of handling tools.
- ☞ Stretching (health education).

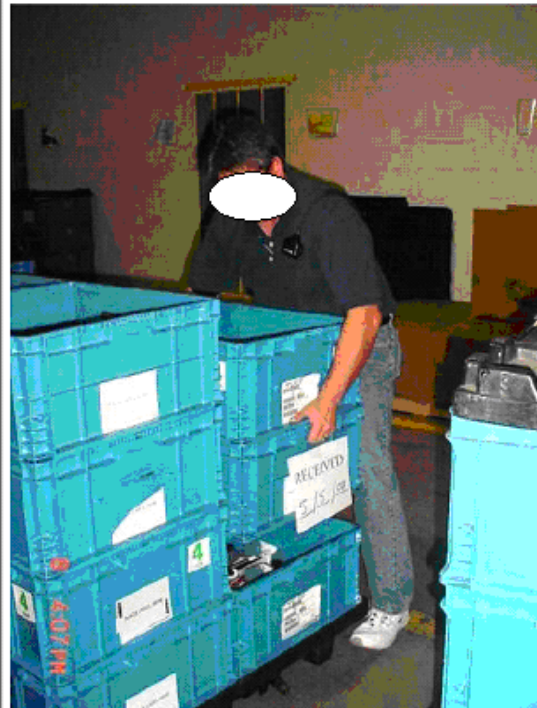
Photo 1: Illustration of incident

- Employees must use good judgement and be aware of their physical limitations.
- Never lift objects at maximum exertion
- Always lighten loads so that exertion is minimal and well within physical limitations
- Always employ proper ergonomic lifting positions; lift with legs not back

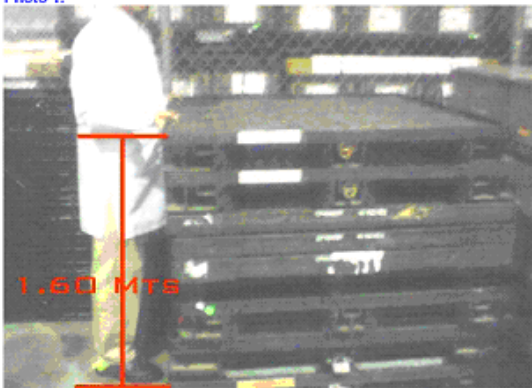
<p><u>Date & Time of Incident:</u> 07 Oct 2008</p> <p><u>DRS Incident number:</u> 7268</p> <p><u>Incident Description:</u> <i>A Production Operator manually tried to move a pallet from the warehouse instead of waiting for a forklift to deliver the pallet to the production floor.</i></p> <p><i>The pallets were stacked to a height of 1.60 m. She took it with both hands and when she pulled it up and to her right side she felt a pain in the low back. The size of the pallet is 1.25 x 1.25 m and a weight of 28 Kg.</i> <i>The employee had been trained and advised not to lower the pallet manually.</i></p> <p><u>Additional information:</u></p> <ul style="list-style-type: none"> ☉ Witness (Y/N): N ☉ Supervisor informed (Y/N), when? Y 07/10/08 6:30 hrs ☉ First time occurrence (Y/N) Y <p><u>Safety Incident Information:</u></p> <ul style="list-style-type: none"> ☉ Injury Type: STRAIN ☉ Affected Body Part: Lower Back ☉ Estimated lost days: 13 ☉ Repetitive disorder (Y/N) N <p><u>Immediate and Root Cause</u></p> <p>Flag (highlight one) : Ergonomics - The employee didn't follow the required procedures. - Improper position to perform the task.</p> <p><u>Interim Containment Action:</u> - The Medical department attended the employee, and assigned her to a different position. On October 08 the employee decided to go to the Social Security, the IMSS delivered the disability forms to the plant to be filled.</p> <p>-A refreshment of the "Performance with the procedure" was deployed to the employees</p> <p><u>Permanent Corrective Action:</u></p> <p>Safety talk with the all employees for involved in the task to identify opportunity areas and to avoid insecure acts</p> <p>Reinforce Safety walks by production supervisor</p> <p>Further actions to be defined once complete investigation are completed.</p>	<p>Photo 1:</p>

<p>The size of the pallet is 1.25 x 1.25 m and a weight of 28 Kg.</p> <p>Photo 2</p>

<p><u>Relevant EH&S Procedure/Standard</u></p> <ul style="list-style-type: none"> ☉ <u>Standard:</u> - Ergonomic ☉ <u>Requires Change to Standard (Y/N):</u> N ☉ <u>EHS Violation or Non - Conformance (Y/N):</u> Y <i>"Non-conformance with the procedure"</i> 	<p><u>Key Learning Points</u></p> <ul style="list-style-type: none"> ☉ <i>Employees should follow all safety procedures even when the job can be done more quickly if safety procedures are ignored.</i> ☉ <i>Implement system of kanban to place the platforms in the use point</i>

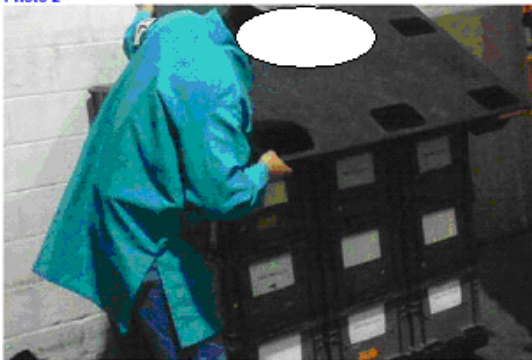
<p>A simulation of the position when the employee was injured (using a pallet which weighs less).</p>

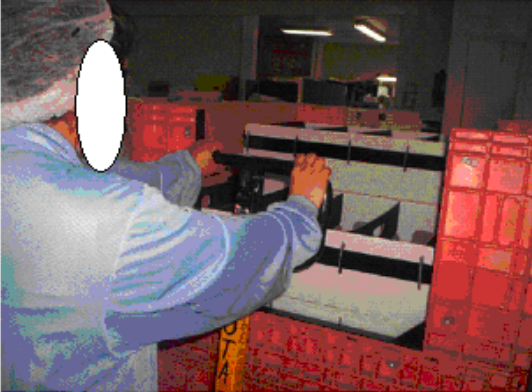
<p><u>Date & Time of Injury:</u> April 04, 2008 - 5:20 a.m. Hours</p> <p><u>Incident Description:</u></p> <p>When the employee was stopping the hydraulic lifter with two hands she felt a pain in the right shoulder due to the force required to stop the load..</p> <p><u>Additional information:</u></p> <ul style="list-style-type: none"> ➤ Injury Type: -<i>Sprain</i> ➤ Affected Body Part: - <i>Shoulder</i> ➤ Estimated lost days: - <i>4</i> <p><u>Root Cause</u></p> <p>Brief Summary:</p> <ul style="list-style-type: none"> • Employee was moving the hydraulic lifter too fast • The employee overexerted her shoulder when she stopped the lifter due to the high inertial force of the load. <p><u>Interim Corrective Action:</u></p> <p>All employees in cell A2 (Assembly) were informed of the accident and Trained in the correct use of the Hydraulic lifter.</p> <p><u>Permanent Corrective Action:</u></p> <p>Training on the correct use of lifter hydraulic for all employees who use them.</p>	<p><u>Photo 1: Illustration of incident</u></p>

<p><u>Relevant EH&S Standard</u></p> <ul style="list-style-type: none"> ➤ <u>Standard:</u> -<i>No</i> ➤ <u>Gap to Standard (Y/N):</u> -<i>No</i> ➤ <u>Safety Non-conformance (Y/N):</u> <i>N</i> ➤ <u>Explain :</u> 	<p><u>Key Learning Points</u></p> <ul style="list-style-type: none"> ➤ Talk to all employees cell by cell A2 (Assy) about this accident. ➤ Training on the correct use of lifter hydraulic.

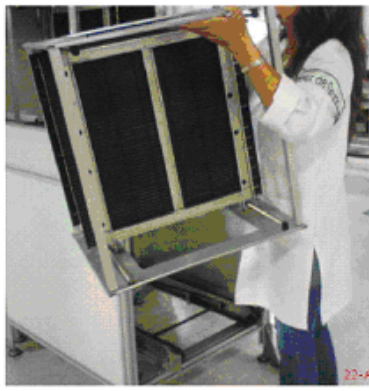
<p>Weigh of the magazine with 15 electronic board =16 Kgs (26 Lbs)</p>

<p><u>Relevant EH&S Procedure/Standard</u></p> <ul style="list-style-type: none"> ⦿ <u>Standard:</u> - Ergonomic ⦿ <u>Requires Change to Standard (Y/N):</u> N ⦿ <u>EHS Violation or Non - Conformance (Y/N):</u> Y ⦿ <i>improper position for the task</i> 	<p><u>Key Learning Points</u></p> <p>Reinforce every six months the Material handling procedures in where includes the different position of the body to move in a safe way any material</p>

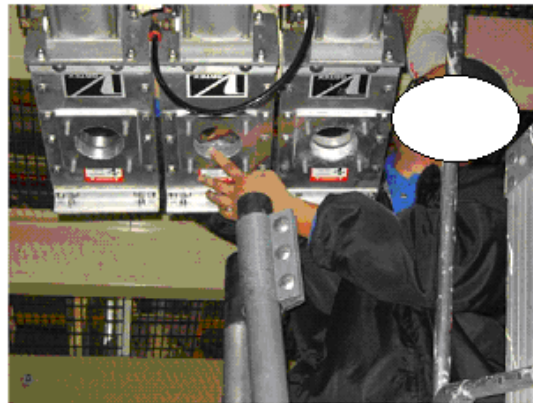
Photo 1: accident / incident

ECPL violation (pneumatic main energy).

- Standard: - Yes
- Requires Change to Standard (Y/N): No.
- EHS Violation or Non-Conformance (Y/N):
 - Yes. [redacted] 100. The employee did not follow the ECPL procedure on the pneumatic main energy.

- Disciplinary action - 0 tolerance for Safety Violations.
- We will buy & implement the quick close valve

- We must continue to apply "ZERO TOLERANCE" for Energy Control and Power Lockout Violations
- Continuous training on hand safety and all safety requirements is important.
- EHS Walks should promote avoidance of unsafe acts and their consequences.
- Un-jamming requires ECPL just like other maintenance tasks

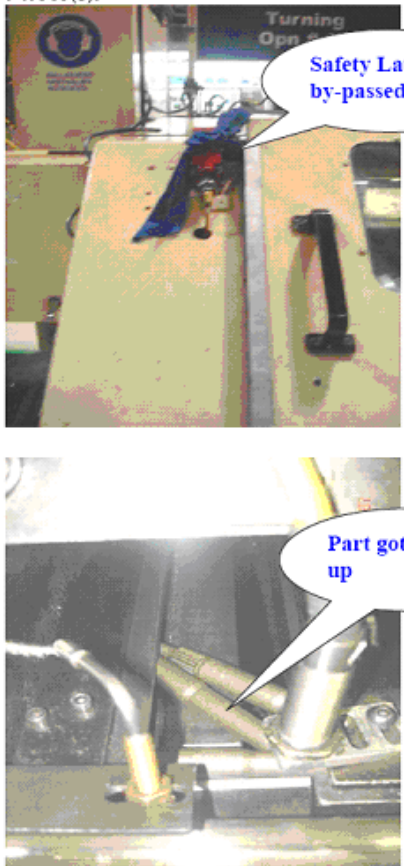
<p> Date: 28/08/2007 Time: 20.10 Hrs Estimated lost days: <input type="text"/> Estimated Date of Return: 21/09/2007 </p> <p> Cause: Safety [Safety / Ergonomic / Motivation / Occupational Disease] </p> <p> Description of Work Performed: <i>Employee was working in TD 30 NCT Turning Machine (operation No. 80).</i> </p> <p> Description of Incident: <i>During this operation the machine displayed a fault message with indication light as the operation sensor could not detect the component in its path. Immediately he opened the main door, and the safety latch was by-passed. He found that the part got struck-up in between the loading chute & the escapement cam, near to the feed tube.</i> </p> <p> <i>The operator didn't reset the fault by pressing the reset button and tried to release the stuck part by his right hand middle finger. As soon as the part got released, the operation sensor sensed the component and as a result, the push rod inside the feed tube got activated and pushed the part on the collet, where his Right Hand Middle Finger was inside the feed tube Slot. Due to this his Right Hand Middle Finger got jammed resulting in injury in the tip of the finger.</i> </p> <p> Affected Body Part: (Rt) middle finger Injury Type: Avulsion of finger pulp </p>	<p>Photo(s):</p>

<p>The top photograph shows a close-up of the machine's safety latch mechanism. A blue tool is used to bypass the latch, and a speech bubble indicates 'Safety Latch by-passed'. The bottom photograph shows the operator's right hand middle finger jammed in the feed tube slot of the machine. A speech bubble indicates 'Part got struck - up'.</p>

<p>Relevant EH&S Standard</p> <ul style="list-style-type: none"> ➤ Standard: ECPL, Contractor work, Machine conception ➤ Gap to Standard (Y/N): Y. ➤ Safety Violation (Y/N): ECPL violation 	<p>Key Learning Points</p> <ul style="list-style-type: none"> ➤ Communication on the accident and a reminding of ECPL importance – <input type="text"/> ➤ Contractor safety training to organize – <input type="checkbox"/> – April

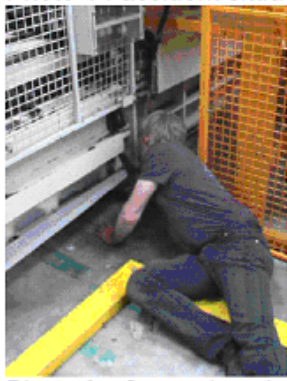
<p>Date and Time of Injury: 04/08/2008, 4.30pm</p> <p>Incident Description: <i>At the end of the cycle of the machine used to do waste plastic ball, the lower metallic wire broke. Seeing that, the operator put his arm under the machine to take the metallic wire and pull it under the tunnel of plastic balls (see the photo). At the moment, the piston of the press started and cut the upper phalanx of the index finger.</i></p> <p>The operator told the nurse that before to put the finger under the machine, he put the machine in the manual mode (normally this mode doesn't authorized a movement without pushing the button "step by step") and that the piston started alone. We found the machine in the manual mode and the selecting button was on the "piston movement". We didn't found any hydraulic failure. We didn't succeed to reproduce any electrical safety failure. We will have a detail study with the machine supplier tomorrow morning. The machine is switch off until checking of the safety function by the supplier and a external control organism.</p> <p>Additional information: the machine in place is not the property of <input type="text"/> but the contractor's one.</p> <p>Interim Corrective Action: <i>Switch off of the machine.</i></p> <p>Root Cause <i>ECPL violation Machine dysfunction ? Machine conception</i></p> <p>Permanent Corrective Action <i>Supplier asking to come in <input type="text"/> plant for studying what could have happen and check all the safety of the machine. The supplier will be in <input type="text"/> plant tomorrow morning Checking of the prevention plan and the regulatory control of the machine Checking of the ECPL material availability</i></p>	<p>Photo 1 : accident situation</p>

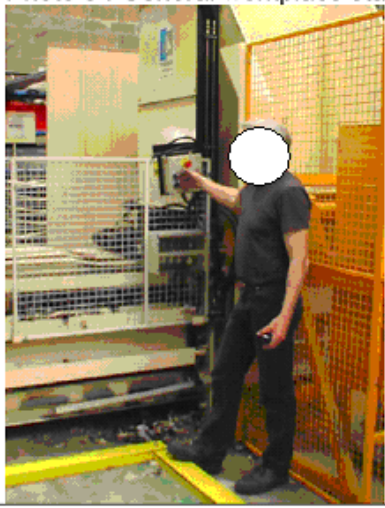
<p>Photo 3 : General workplace station view</p>

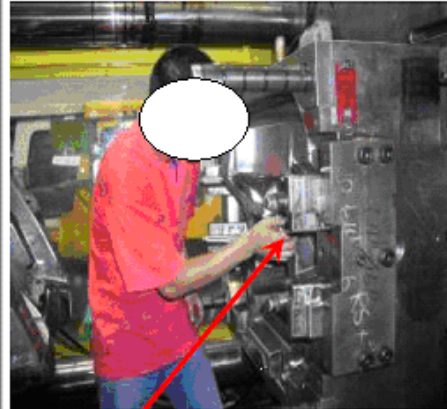
Photos:

Burn to the back of hand and arm.

- This is a hot runner mold with PBT material.
- The employee went inside the machine to clean the mold without following proper safety procedure.
- Ensure all employees are aware of the proper procedures, including backing up barrel and turning off both temperature box and motor prior to cleaning the mold.

- Declare to the employee that the barrel must be backed up, the motor and temperature box must be turned off for the hot runner mold.
- Employee was fined 150 RMB for failure to follow existing safety rules.

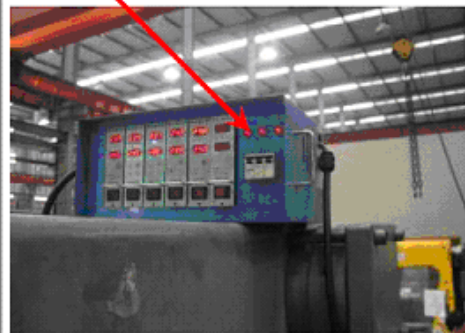
Material ejected out from here
The Temperature box was not turned off

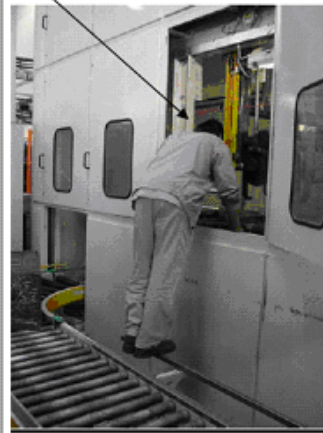
Place where employee's neck was squeezed.

- „Failure signalling device“ on control panel did not record any failure on equipment before the time of the incident!!
- Despite this - and for unknown and unbelievable reason - the employee performed this forbidden activity – he opened one of the cover door (each part of cover door is secured at the top and bottom by 2 mechanic locks)
- All these activities were performed by the employee while the equipment was in operation.
- Serious violation of ECPL rules

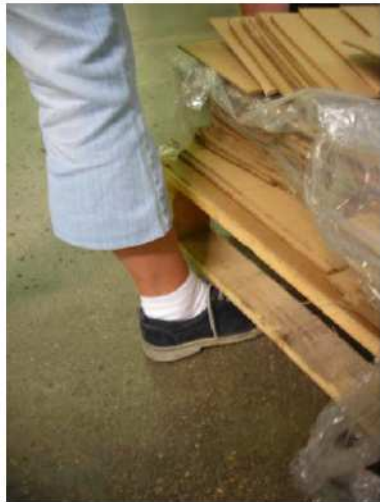
<p>Date: August 27th 2007 Time: 13h30</p> <p>Description of Work Performed: <i>Skilled worker</i></p> <p>Description of Incident: By raising a pallet, Mrs D. has slid on a puddle of oil. She has dropped the pallet that fell on her left foot.</p> <p>Injuries: Fracture at the left foot</p> <p>Estimate date of return: 25th September 2007 = 20 day's loss</p>	<p>Photo:</p>

<p><u>Key Point Summary</u></p> <ul style="list-style-type: none"> ➤ Keep attention while carrying out the job ➤ Systematic cleaning of the puddles of oil 	<p><u>Key Learning Points</u></p> <ul style="list-style-type: none"> ➤ Obligation to use our hand-lift truck to move one pallet ➤ To improve our efficiency to clean quickly after oil leakage

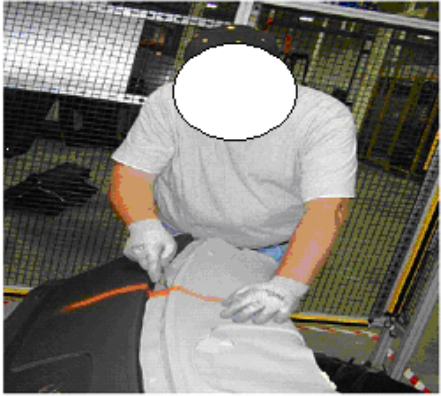
<p><u>Date & Time of Injury:</u> May 20, 2009</p> <p><u>Incident Description:</u> An employee was using a box cutter to trim excessive foam and vinyl from GM instrument panel. The employee was using left hand to hold/steady the instrument panel and cutting with his right hand. His right hand slipped and he cut his left thumb. The cut required 5 stitches. The employee was not wearing gloves or cut protection sleeves.</p> <p><u>Additional information:</u></p> <ul style="list-style-type: none"> ⦿ <i>Witness (Y/N):</i> - Y ⦿ <i>Supervisor informed, when:</i> - Immediately ⦿ Flag: first time or repetitive disorder: first time ⦿ Injury Type: Laceration ⦿ Affected Body Part: Left thumb <p>Estimated lost days: 0 days</p> <p><u>Root Cause</u></p> <p>Flag: Safety</p> <ul style="list-style-type: none"> - Employee not wearing required PPE <p><u>Interim Corrective Action:</u></p> <ul style="list-style-type: none"> - Safety Stand down - Emphasize - Conduct several audits per shift to ensure required PPE is being worn <p><u>Permanent Corrective Action:</u></p> <ul style="list-style-type: none"> - TBD 	<p>Photo:</p>

<p><u>Relevant EH&S Standard</u></p> <ul style="list-style-type: none"> ⦿ <u>Standard:</u> Personal Protective Equipment ⦿ <u>Gap to Standard (Y/N):</u> Yes ⦿ <u>Safety Violation (Y/N):</u> Yes 	<p><u>Key Learning Points</u></p> <ul style="list-style-type: none"> ⦿ Always wear required personal protective equipment. ⦿ Do not use your non-cutting hand to steady or hold what is being cut if it is in the path of the cut. ⦿ Use safety knives with auto-retracting blades when possible.

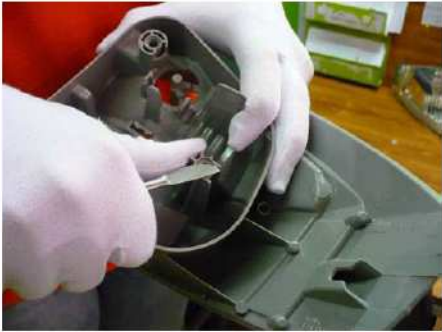
<p>Date : 20.08.2007 Time : 16:00</p> <p>Estimated lost days : 3 days Estimated Date of Return : 23.08.2007</p> <p>Cause : Safety [Safety / ergonomic / Motivation / Occupational Disease]</p> <p>Description of Work Performed : Automatic molding process of plastic body with manual removing of plastic overflows .</p> <p>Description of Incident : During manual removing of plastic overflows around and inside the plastic body by scalpel, the operator has cut her left forefinger , near to nail socket .</p> <p>Injuries : left forefinger /affected body parts /</p> <p>Injury type : cut injury</p> <p>Immediate corrective action :</p> <ul style="list-style-type: none"> - first aid , medical treatment - verification of protective equipment and tool 	<p>Photo :</p> <p>Improper hold of plastic body – scalpel movement is going against finger</p>

<p><u>Key Point Summary</u></p> <ul style="list-style-type: none"> ☞ - Improper working procedure ☞ - High occurrence of overflows, molding tool capability 	<p><u>Key Learning Points</u></p> <ul style="list-style-type: none"> ☞ - Update of working instruction ☞ - Periodical safety training and introduction to corrective action ☞ - Adjustment of molding tool

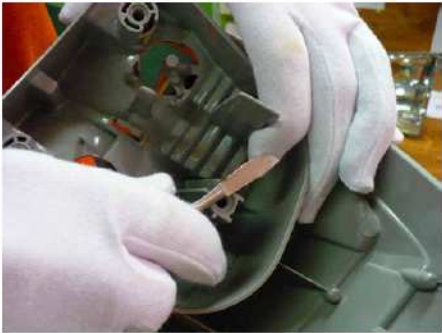
<p>Due to slipped scalpel the operator injured her forefinger through the protective cotton glove</p>

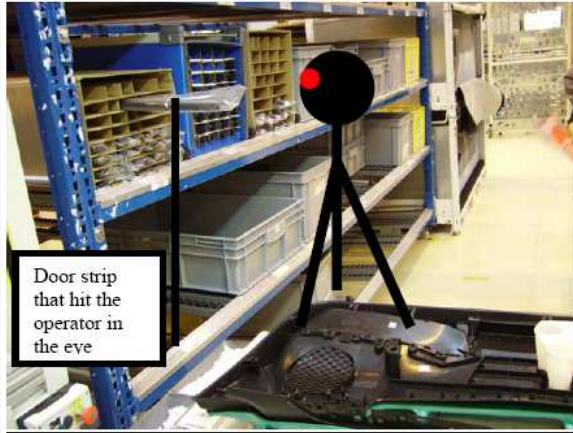
<p>Date: 14.12.2007 Time: 15:00</p> <p>Description of Work Performed: <i>The operator was assembling door panel</i></p> <p>Description of Incident: <i>While normal operation on assembly line – picking – a Quality Engineer was checking the quality of door strips very close to production operator. Production operator turned his head right. At the same time Quality Engineer took one of the door strips out from the rack and hit the operator in the eye.</i></p> <p>Injuries: Small scratch in the eye</p>	<p>Photo:</p>

<p><u>Key Point Summary</u></p> <p>➤ Wrong organization of work</p>	<p><u>Key Learning Points</u></p> <p>➤ The quality control of door strips will be made out of the rack</p> <p>➤ Information to all employees about the accident</p> <p>➤ Always wear safety glasses where there is risk to your eyes.</p>

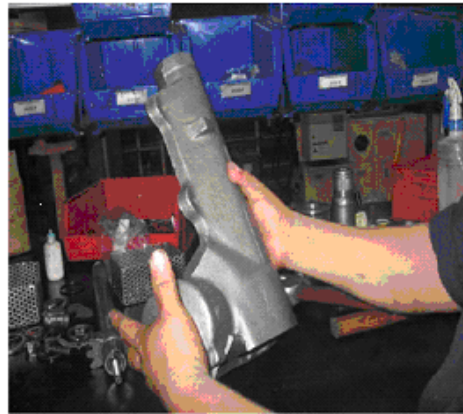
Photo :

Immediate Cause: The gear slipped down from his hand.

- The gear wasn't clean. It had grease in its surface and the employee can't manipulate the gear properly.
- The employee was not wearing the safety gloves for this job position.

- Improve the safety talks about the use of the PPE.
- The plant will evaluate the use of other gloves due to employees comments; some employees said that they some times don't wear the gloves because are not adequate to manipulate either big or small parts at the same time. They have to do that in this job position.
- The supervisor will review that the parts that previously were in the rework area must be cleaned before start this job position.

- Wear the correct PPE every time.
- Parts that come from the rework area must be washed and reviewed before start this job position.

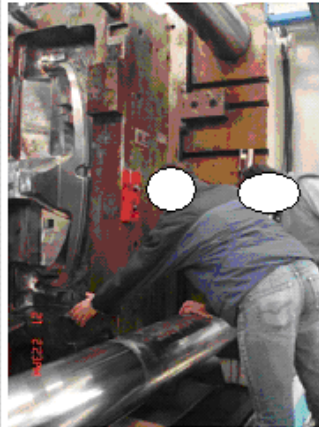
Photo 1:

- Electrical maintenance worker burned his left hand while removing solid plastic material from a mould as the first step in order to start the injection press and analyse robot failure.

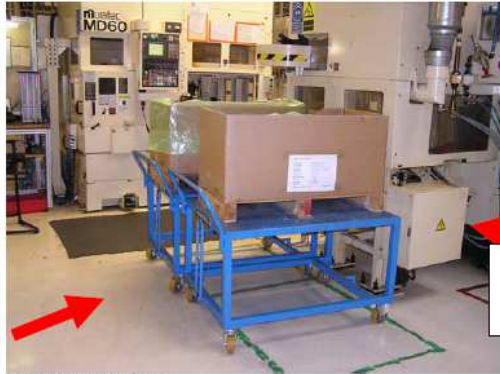
<p><u>Date & Time of Injury:</u> 25/February /18:30 pm</p> <p><u>Incident Description:</u></p> <p>The employee wanted to pick up the reject parts from the chute behind the Murata machine. She went next to the machine and slipped on the floor, which was dirty by coolant, which was come from the employees' shoes.</p> <p><u>Additional information:</u></p> <ul style="list-style-type: none"> ☞ witness (Y/N): Y(colleague) ☞ supervisor informed, when: Yes, at once ☞ Flag: first time ☞ Injury Type: bruise ☞ Affected Body Part: sacro-iliac ☞ Estimated lost days: 15 <p><u>Root Cause</u></p> <p>Flag: Environmental / Safety / Ergonomic / Fire / Occup. diseases</p> <p>-the floor was dirty</p> <p><u>Interim Corrective Action:</u></p> <p>-clean the floor</p> <p><u>Permanent Corrective Action:</u></p> <p>-work process modifying – the employee, who make the visual check, will be collect the reject pieces -shall fix the salvagers around the all machines In whole machining area -shall find a solution that less coolant come out the machines</p>	<p>Photo 1: accident / incident</p>

<p>She walked here</p>

<p><u>Relevant EH&S Standard</u></p> <ul style="list-style-type: none"> ☞ <u>Standard:</u> - housekeeping ☞ <u>Gap to Standard (Y/N):</u> -N ☞ <u>Safety Violation (Y/N):</u> -Y decrease housekeeping 	<p><u>Key Learning Points</u></p> <ul style="list-style-type: none"> ☞ -Keeping a good floor condition next to machine as well ☞ -Checking the salvages periodically

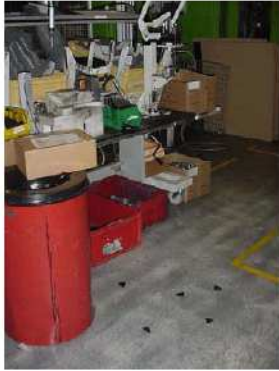
<p><u>Date & Time of Injury:</u> Jan. 16th. 2008 / 12:40 pm</p> <p><u>Incident Description:</u></p> <p>Work not started yet, happen when operator arrives at work station. During walking, the operator walks on a sprue (scrap plastic part), slides and twists her ankle. Employee wore safety shoes</p> <p><u>Additional information:</u></p> <ul style="list-style-type: none"> ➤ witness (Y/N): Y (colleagues) ➤ supervisor informed, when: immediate ➤ Flag: first time or repetitive disorder: ➤ Injury Type: strain ➤ Affected Body Part: left ankle ➤ Estimated lost days: 7 <p><u>Root Cause</u></p> <p>Flag: Environmental / Safety / Ergonomic / Fire / Occup. diseases housekeeping</p> <p><u>Interim Corrective Action:</u></p> <p>Floor cleaned. Housekeeping at each shift end reminded to all operators</p> <p><u>Permanent Corrective Action</u></p> <p>ditto</p>	<p>N216</p>

<p><u>Relevant EH&S Standard</u></p> <ul style="list-style-type: none"> ➤ <u>Standard:</u> housekeeping ➤ <u>Gap to Standard (Y/N):</u> N ➤ <u>Safety Violation (Y/N):</u> Y <p>Lack of housekeeping at shift end.</p>	<p><u>Key Learning Points</u></p> <ul style="list-style-type: none"> ➤ employee behaviour, take housekeeping seriously ➤ Perform a 5 min safety talk to the operators to remind importance of housekeeping.

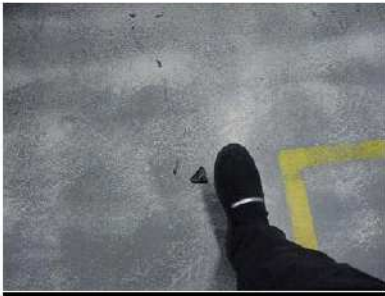
<p>Photo 2: accident simulation</p>

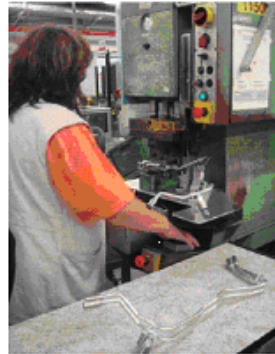
Photo 1: crimping machine with two hand start buttons

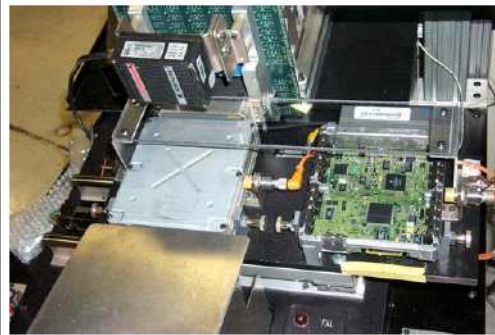
Photo 2: Program head in closed position with new guard installed.

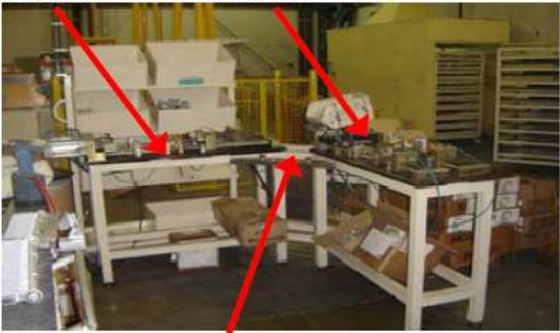
<p><u>Date & Time of Injury:</u> 29/01/2008, 23:10</p> <p><u>Incident Description:</u> <i>While being trained to perform an operation, the employee laid on the 2nd station's device of the machine and when this was put to work, the device strained his right hand ring finger and produced a cut.</i></p> <p><u>Additional information:</u></p> <ul style="list-style-type: none"> ➤ Witness (Y/N): Y Co worker ➤ Supervisor informed, when: <i>immediately</i> ➤ Injury Type: <i>strain & cut</i> ➤ Affected Body Part: <i>ring finger right hand</i> ➤ Estimated lost days: 14 <p><u>Root Cause</u> <i>Flag: Environmental / Safety / Ergonomic / Fire / Occup. diseases</i></p> <p><u>Substandard Condition:</u> N/A</p> <p><u>Interim Corrective Action:</u> <i>There were placed signs on the proper use of the machine.</i></p> <p><u>Permanent Corrective Action</u></p> <ul style="list-style-type: none"> ◆ <i>We have requested the separation of the second position, which was planned to be done shortly.</i> ◆ <i>Install a blocking system, a separation for the unused position.</i> ◆ <i>Place warning signs on the unused section.</i> ◆ <i>Place signs on the proper use of the machine.</i> 	<p><u>Photo:</u></p> <div style="text-align: center;"> <p>Station 1 Station 2</p>

<p>Triggering Device</p> </div> <div style="text-align: center;"> <p>Action Device</p>

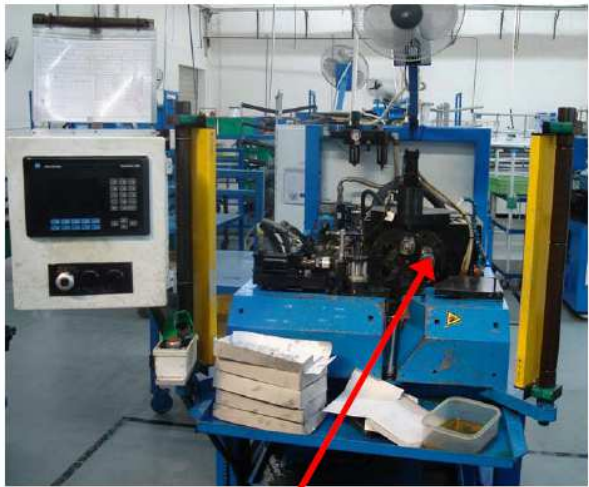
<p><u>Date & Time of Injury:</u> March 25, 2009, 5:50 pm</p> <p><u>Incident Description:</u> The operator did not follow endforming machine operating instructions while he was running the machine. He placed fitted parts with right hand as the machine was still cycling and he injured his right thumb.</p> <p><u>Additional information:</u></p> <ul style="list-style-type: none"> ➤ <u>Witness (Y/N):</u> Y ➤ <u>Supervisor informed, when:</u> immediate ➤ <u>Injury Type:</u> Pinch ➤ <u>Affected Body Part:</u> Right thumb ➤ <u>Estimated lost days:</u> One month <p><u>Root Cause</u></p> <p><i>Flag: Environmental / Safety / Ergonomic / Fire / Occup. diseases</i></p> <p><u>Substandard Act:</u></p> <ol style="list-style-type: none"> 1. The product was made with a new endforming technique using a manual feeding method. 2. The operator did not follow safe operating instructions. <p><u>Substandard Condition:</u></p> <ol style="list-style-type: none"> 1. Light curtain not functioning since Feb 24, 2009. Side guards to machine also not present. <p><u>Interim Corrective Action:</u> Team leader will summon endforming team for accident and safety training, and will be conducted for all operators stressing importance of obeying safety rules.</p> <p><u>Permanent Corrective Action</u></p> <ol style="list-style-type: none"> 1. Add endforming operating rules into safety training and checklist. 2. Make feeder to replace current manual feeding mode. 3. Replace the light curtain to prevent risk of operating approaching cycling machine. 	<p><u>Photo:</u></p>

<p style="text-align: center;">Fitting parts input position</p>

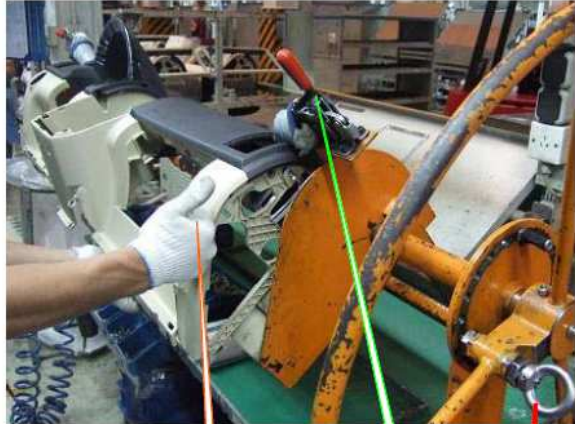
<p><u>Date & Time of Incident:</u> May 28th 2009 14:45</p> <p><u>Incident Description:</u> At about 14:45 on May 28, employee was pre-loading the panel. Since the coil spring of jig dowel pin did not function and the distance between clam bucket and panel was too long, the panel got loose and fell from the jig and fixture. The panel and the jig system were sent from the supplier. Employee supported the panel with his hands that lead his right hand injured.</p> <p><u>Additional information:</u></p> <ul style="list-style-type: none"> ➤ Witness (Y/N): Y ➤ Supervisor informed (Y/N), when? Y, 16:00 1/6/2009 ➤ First time occurrence (Y/N) Y <p><u>Safety Incident Information:</u></p> <ul style="list-style-type: none"> ➤ Injury Type: Fracture ➤ Affected Body Part: Right hand (the 5th metacarpal) ➤ Lost days: 60 days (comply with GBT15499-1995) ➤ Repetitive disorder (Y/N) N <p><u>Immediate and Root Cause</u></p> <ol style="list-style-type: none"> 1. The coil spring of jig dowel pin broke down and the self-locking did not function. So the jig and fixture system with the panel over rotate by the gravity. The supplier was asked to repair the coil spring on May 20, but the maintenance Dept. of the supplier did not fix it because they were lack of the spares. 2. The distance between clam bucket and panel was too long that makes the panel got loose and fell from the jig and fixture by over rotation. <p>Flag (highlight one) : <i>Environmental / Safety / Fire / Occup. diseases</i></p> <p><u>Interim Containment Action:</u></p> <ol style="list-style-type: none"> 1. Sent the injured person to the hospital immediately; 2. Ask the supplier to fix the coil spring of dowel pin. <p><u>Permanent Corrective Action:</u></p> <ol style="list-style-type: none"> 1. The maintenance Dept. of the supplier added the permanent limit on the jig to avoid over rotation even the self-lock does not function (May 30th). 2. Required every operator to do the inspection of the jig and fixture system before pre-loading. Notify the supplier if there is any problem and ensure that has been fixed (from June 1st). 3. Ask the supplier to keep enough spare parts (June 2nd). 4. Required the supplier to adjust the distance between clam bucket and panel (June 5th). 	<p>Photo 1:</p> <ol style="list-style-type: none"> A. The coil spring of jig dowel pin from the supplier did not function. B. Because the distance between clam bucket and panel was too long, the panel got loose and fell from the jig and fixture by over rotation. C. The operator supported the panel with his hand to prevent the panel from falling to the ground.

<p><u>Relevant EH&S Procedure/Standard</u></p> <ul style="list-style-type: none"> ➤ <u>Standard:</u> N ➤ <u>Requires Change to Standard (Y/N):</u> N ➤ <u>EHS Violation or Non-Conformance (Y/N):</u> N 	<p><u>Key Learning Points</u></p> <p>-Enhance the risk investigation for the tooling, fig, tool and working environment of the suppliers. -Avoid using anything that breaks down even if it is from the suppliers.</p>

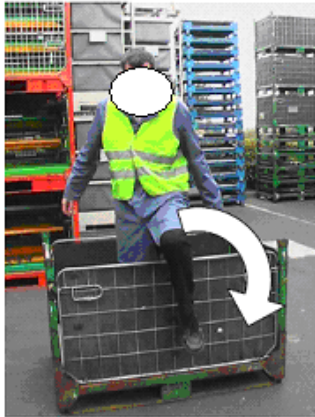
<p>Date: 10/13/2007 Time: 1 am</p> <p>Description of Work Performed: --- The forklift driver was preparing metallic conditioning unit on a workplace station.</p> <p>Description of Incident: - The forklift driver was preparing some conditioning units at the X32 workplace station. For that, he opened 3 of the 4 metallic gates of one unit. During the opening of the third gate, he was inside the conditioning unit. After that, he tried to remove the fourth gate to leave the access of the unit free to load pieces of X32 process. He didn't succeed to remove this gate but he left it opened in despite the gate was functioning normally. As he was inside the unit, he get over the gate of the unit and his right foot struck the gate and he felt on his left knee.</p> <p>Injuries: -- Pain on his left knee – 5 days off</p>	<p>Photo:</p>

<p><u>Key Point Summary</u></p> <ul style="list-style-type: none"> ➤ Bad practices used by the forklift driver to open the gates ➤ Inattention of the forklift driver to get over the conditioning unit 	<p><u>Key Learning Points</u></p> <ul style="list-style-type: none"> ➤ Reminding of the good practices to open this kind of gate – learning lesson – <u> </u> ➤ Reminding of the procedure in place in case of the non conform gate : if a conditioning unit is not conform, the worker don't have to use it – learning lesson – <u> </u>

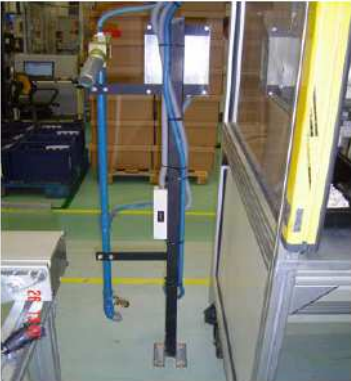
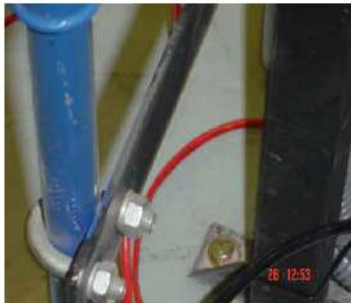
<p>Date: 24-11-07 Time: 14:30</p> <p>Description of Work Performed: ---</p> <p>Description of Incident: During disassembling process of an interrupter pole (photo1) the base of the interrupter tilted up and caused a cut injury as the technician try to keep hold on with the right hand. The injury has been caused by the screws, to attach the pole at the pneumatic pipe.</p> <p>Injuries: Superficial cut injury finger right hand. Injury has been treated with a suture, 10 stitches.</p>	<p>Photo:</p>

<p><u>Key Point Summary</u></p> <ol style="list-style-type: none"> 1. The base of the interrupter was dismantled , the operator was expecting that the electrical cable could sustain the interrupter. 2. It complicated the use of gloves by the work to be done. 3. The screws are not protected with plastic covers 	<p><u>Key Learning Points</u></p> <ol style="list-style-type: none"> 1. Risk Assessment for specific jobs need to be done. 2. clear Safety procedure for this job must be set and strictly adhered to stabilize the interrupter. 3. second operator should be there in stand-by position. 4. In these installations all screws should be protected with plastic covers 5. Plant engineering must be informed about this incident and trained in Safety Rules & Procedures

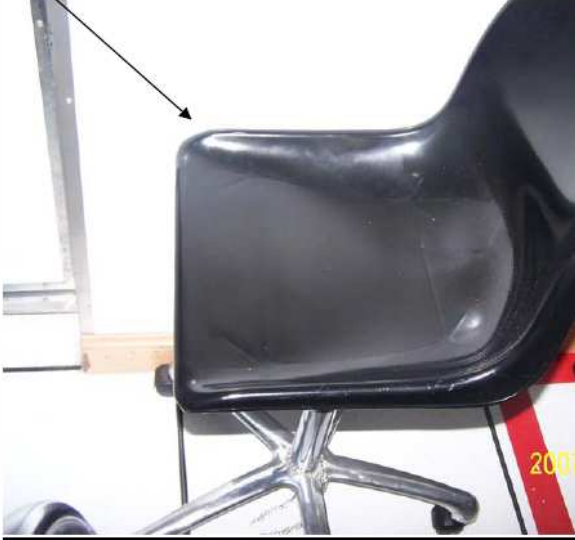
<p>Date : October 19, 2007 Time: 4:20 PM</p> <p>Description of Work Performed: Operation Department employee fell after changing height of chair.</p> <p>Description of Incident: After operator of operations department changed the height of the chair, she went to sit. When she went to sit down, the chair slid and she fell to the ground. She felt some pain in her lower back and went to Songjian Hospital.</p> <p>Injuries: A subsequent visit rendered a diagnosis of a break of the S5 vertebrae (broken tailbone). Return date estimated currently at November 20, 2007.</p>	<p>Photo(s): Chair employee slipped from.</p>

<p><u>Key Point Summary</u></p> <ul style="list-style-type: none"> ➤ 1. Pay attention and check to see if the chair is stable. ➤ 2. Ensure the chair location is suitable. ➤ 3. Sit down slowly. ➤ 4. Chair height should be suitable. 	<p><u>Key Learning Points</u></p> <ul style="list-style-type: none"> ➤ 1. training to all employee; ➤ 2. Strengthen safety supervision.

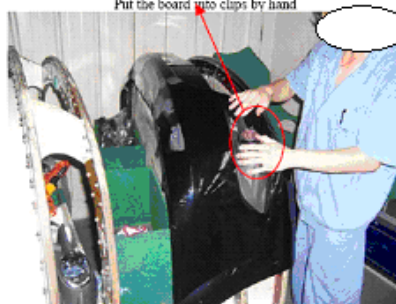
CD132 fog lamp board assembly of front bumper
Put the board into clips by hand

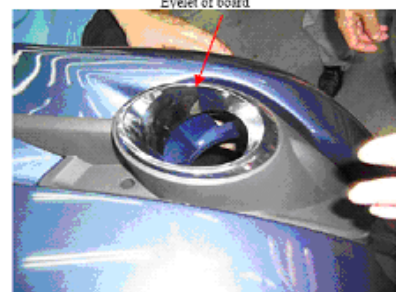
Eyelet of board

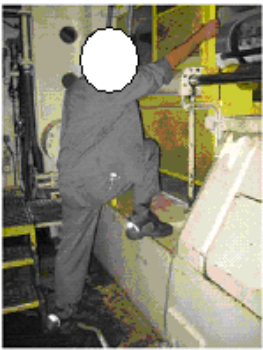
<p>Photo 2: re-enactment of the accident!</p>

<p><u>Date & Time of Injury:</u> 26.Sep.2008 / 10:00 am</p> <p><u>Accident Description:</u> <i>The employee wanted to push a switch on the injecting moulding material hopper. He does not use the ladder when he climbed up the injection unit. He slipped and felled (approx. 60 cm) on the floor!</i></p> <p><u>Additional information:</u> ☞ witness (Y/N): Y ☞ supervisor informed, when: immediate ☞ Flag: first time or repetitive disorder: first time</p> <p>☞ Injury Type: <i>contusion & laceration</i> ☞ Affected Body Part: <i>thigh & back</i> ☞ Estimated lost days: 10</p> <p><u>Root Cause</u> ☞ Unsafe work</p> <p><u>Interim Corrective Action:</u> <i>Safety talk to all employees! Discipline action!</i></p> <p><u>Permanent Corrective Action</u> <i>> Re-instruction of all employees on a regular basis via safety talks</i></p>	<p>Photo 1: injecting moulding machine!</p>

<p><u>Relevant EH&S Standard</u></p> <p>☞ <u>Standard:</u> : -yes</p> <p>☞ <u>Gap to Standard (Y/N):</u> -yes</p> <p><u>Safety Violation (Y/N):</u> -yes</p>	<p><u>Key Learning Points</u></p> <p>☞ Zero tolerance to unsafe action during safety walks!</p> <p>☞ Ladder handling training for all tool-setter and maintenance people!</p>

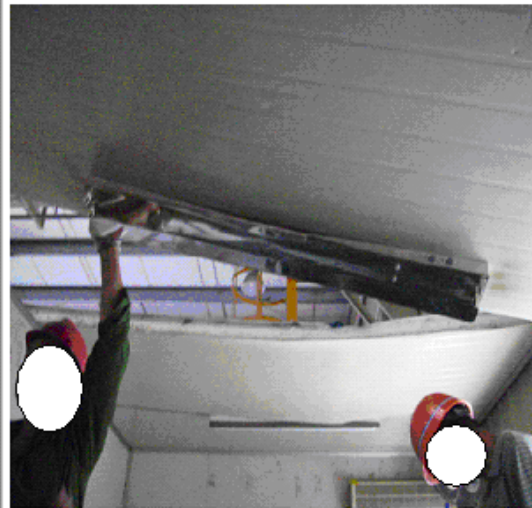
Photo 1:

At 15:10 on September 16, a non-load-bearing roof caved in when two employees were doing some clean up on the roof. They fell from the roof onto the ground. Mr. Yao Jun is OK and in good condition. Mr. [redacted] two bottom ribs on right side were broken and got fracture.

1. Finish and improve the SOP of every operation and equipment and put it into action immediately.
2. Strengthen the safety training of the employees and the inspection on site to enhance employee's safety consciousness.
3. Carry on a safety inspection of all the non-load-bearing roofs, strictly forbid to put any miscellaneous goods on it and put up the caution marking.
4. Perform the investigation of non-load-bearing roof and the hanging chain protection net made of the foam aluminium in the plant. Add some bearing reinforcing bar or some other protection.

- Improve the management and training for the high work operation.
- Pay more attention to the non-loading-roof and put up the cautions.

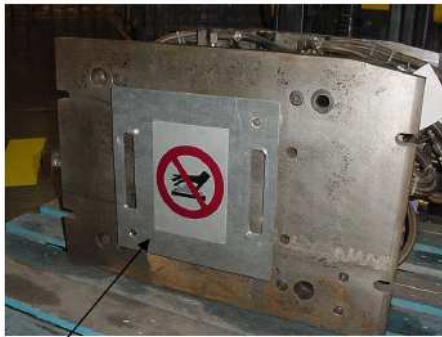
<p>Protection plate built to avoid burnings</p>

<p><u>Key Point Summary</u></p> <ul style="list-style-type: none"> ➤ No physical protection available to avoid plastic projection in case of degasses. ➤ Lack of PPE usage. 	<p><u>Key Learning Points</u></p> <ul style="list-style-type: none"> ➤ Install physical protections and safety labels. ➤ Perform a 5 min safety talk to the operators involved with plastic to remind PPE usefulness.

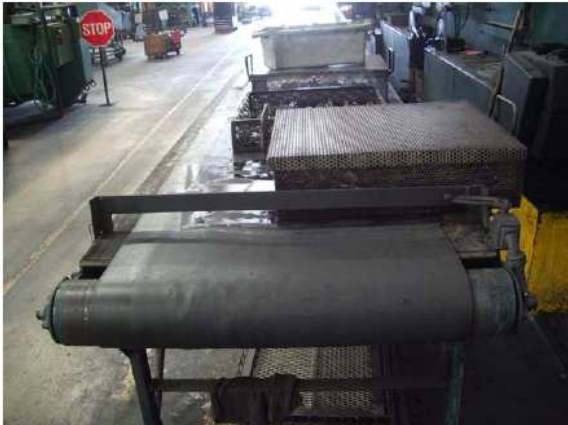
<p>Date and Time of Injury: 9/18/07 8:00 AM</p> <p>Problem Description: Employee tried to align a conveyor belt while it was still in motion with his hand and looked away as he gripped the belt and his fingers got caught between the belt and roller. There is a safety switch that turns the conveyor off when parts reach the end of the line and the employee was reaching behind the safety device, had he been in front of the device the injury would not have occurred.</p> <p>Interim Corrective Action: Instructed operator not to attempt adjusting the belt with their hands and never reach behind the safety stop.</p> <p>Root Cause: There was not enough guarding on the equipment and the employee was reaching behind the safety stop.</p> <p>Permanent Corrective Action: Additional guarding will be fabricated for the equipment and employees have been retrained not to get anything off the belt while the belt is in motion.</p>	<p>Photo:</p>

<p><u>Key Point Summary</u></p> <ul style="list-style-type: none"> ➤ Machine should have had more guarding ➤ Employee should not have reached behind the safety device. ➤ 	<p><u>Key Learning Points</u></p> <ul style="list-style-type: none"> ➤ <i>The equipment had been in operation for over two years without an incident but we should have discovered the issue prior to an incident.</i> ➤ <i>Never ever relax when it comes to safety.</i> ➤

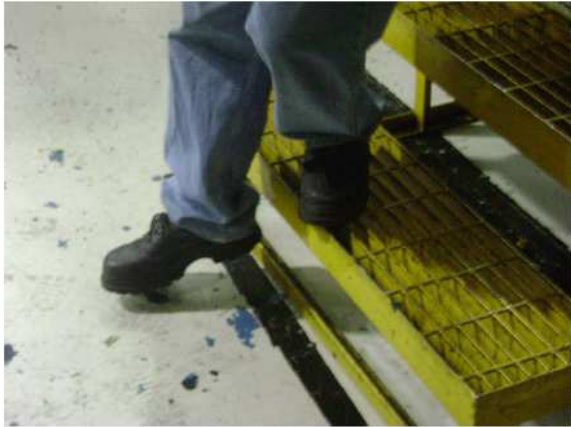
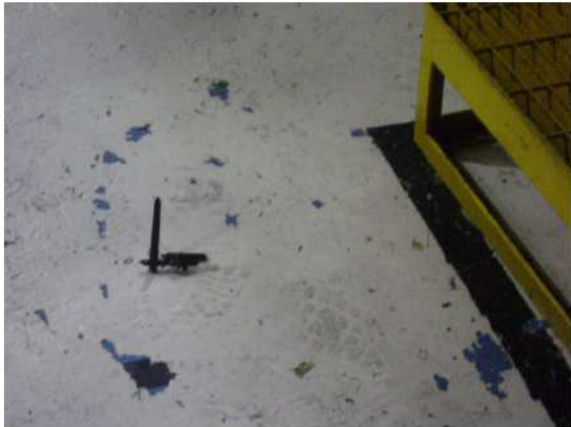
<p><u>Date & Time of Incident:</u> 05/30/2008 11:00 am <u>DRS Incident number:</u> 6275 <u>Incident Description:</u></p> <p><i>Female stepped off a ladder on to the floor and slipped on a plastic gate. When she fell, she struck the back of her shoulder and strained her neck in the effort to avoid striking her head.</i></p> <p><u>Additional information:</u></p> <ul style="list-style-type: none"> ➤ Witness (Y/N): No ➤ Contact: ➤ Supervisor informed (Y/N), when? Yes, 11:05 a.m. ➤ Has this occurred before? (Y/N) Nt. <p><u>Safety Incident Information:</u></p> <ul style="list-style-type: none"> ➤ Injury Type: - Fall of different level ➤ Affected Body Part: - Right shoulder and Neck ➤ Estimated lost days: - 4 ➤ Repetitive disorder (Y/N) - No. <p><u>Immediate and Root Causes</u></p> <p><i>Flag (highlight one) :</i> Safety - Poor Housekeeping</p> <p><u>Interim Containment Action:</u></p> <ul style="list-style-type: none"> - Safety talk covering the accident - Housekeeping in the area <p><u>Permanent Corrective Action:</u></p> <p>- Implement the new mold of EN114 rolling operation to eliminate semiautomatic requirement to climb stairs</p>	<p>Photo 1: accident / incident</p>

<p><u>Relevant EH&S Procedure/Standard</u></p> <ul style="list-style-type: none"> ➤ <u>Standard:</u> - Housekeeping ➤ <u>Requires Change to Standard (Y/N):</u> No - ➤ <u>EHS Violation or Non-Conformance (Y/N):</u> Yes <ul style="list-style-type: none"> - Non-conformance – Poor housekeeping 	<p><u>Key Learning Points</u></p> <ul style="list-style-type: none"> - Always maintain housekeeping the work area. - Avoid operation on semi-automatic machines for long periods.

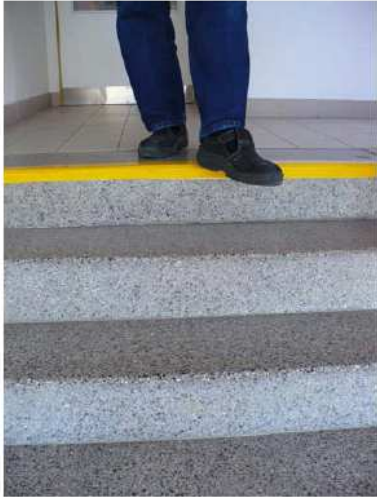
<p><u>Date & Time of Injury:</u> 11/06/08 13:40 p.m.</p> <p><u>Incident Description:</u></p> <p>When walking from the cloak room downstairs the operator slipped on the first step and suffered at bad pace a middle contusion of left ankle. Operator wore safety shoes, the floor and stairs without visible dirt, oil or wet surface.</p> <p><u>Additional information:</u></p> <p> <input type="radio"/> witness (Y/N): Y / assy line operator / <input type="radio"/> supervisor informed, when: Y - asap <input type="radio"/> Flag: first time or repetitive disorder: first issue </p> <p> <input type="radio"/> Injury Type: contusion <input type="radio"/> Affected Body Part: left leg / ankle <input type="radio"/> Estimated lost days: 11 days </p> <p><u>Root Cause</u></p> <p>Flag: Environmental / Safety / Ergonomic / Fire / Occup. diseases</p> <p>Inattention</p> <p><u>Interim Corrective Action:</u></p> <p> - Repeated regular safety training - Inspection of housekeeping of stairs, corridors, etc. </p> <p><u>Permanent Corrective Action:</u></p> <p>- Implement an extra chapter about pedestrian safety for Input safety training .</p>	<p>Photo 1: incident</p>

<p>Slip & fall on the first step (illustration photo)</p>

<p><u>Relevant EH&S Standard</u></p> <p> <input type="radio"/> <u>Standard:</u> - N <input type="radio"/> <u>Gap to Standard (Y/N):</u> - N <input type="radio"/> <u>Safety Violation (Y/N):</u> - N </p>	<p><u>Key Learning Points</u></p> <p> <input type="radio"/> Permanent observance of all safety rules for pedestrians <input type="radio"/> Regular inspection of housekeeping and relevant marking of unsafe spaces / see Visual Management / </p>

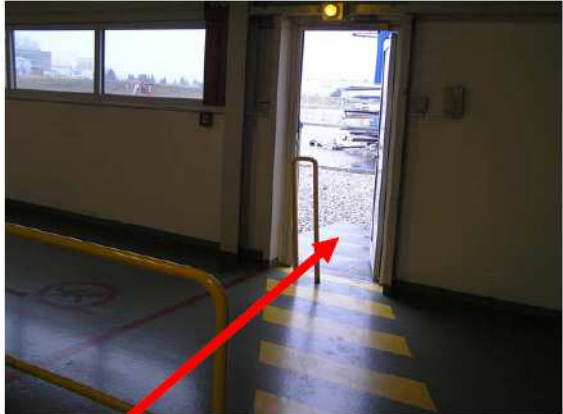
<p>Date & Time of Injury: 14/ January/08:30 am</p> <p><u>Incident Description:</u></p> <p>One of the employee from the Fuel Pump Production area went back from the cafeteria to her workplace and tried to make short cut using a door to outside of the building. After opening the door as she stepped out from the building, she slipped on the icy concrete and fell onto her right hand arm. Weather was sleety and freeze, so there was a 3 mm thick ice on everything outside the building.</p> <p><u>Additional information:</u></p> <ul style="list-style-type: none"> ➤ <i>witness (Y/N):</i> No ➤ <i>supervisor informed, when:</i> at once ➤ <i>Flag:</i> first time ➤ Injury Type: fracture- ➤ Affected Body Part: right wrist (radius & ulna crashed) ➤ Estimated lost days: 30 work days- <p><u>Root Cause</u></p> <p><i>Flag: Environmental / Safety / Ergonomic / Fire / Occup. diseases</i></p> <p><i>The area outside of the building was icy because of sleety weather which has started to fall 30 minutes prior to the accident and that door was not supposed to use for normal pedestrian traffic.</i></p> <p><u>Interim Corrective Action:</u></p> <p><i>The walking surface was de-iced and signs for slippery hazard were added to other doors like that. Plant employees were notified about the proper using of the pedestrian walkways inside and outside of the buildings.</i></p> <p><u>Permanent Corrective Action:</u></p> <p>All doors including emergency and not frequently used doors will have de-icing material and security will make sure that in case of extreme weather conditions (sleeting, freezing...), the outside area of the doors are de-iced and production teams/team leaders are notified.</p>	<p>Photo 1: accident scene</p>

<p>Slip point</p>

<p><u>Relevant EH&S Standard</u></p> <ul style="list-style-type: none"> ➤ <u>Standard:</u> - ➤ <u>Gap to Standard (Y/N):</u> N ➤ <u>Safety Violation (Y/N):</u> - 	<p><u>Key Learning Points</u></p> <ul style="list-style-type: none"> ➤ On first week was provided a message about "Health and Safety Start Up" to all employees via News Letter.

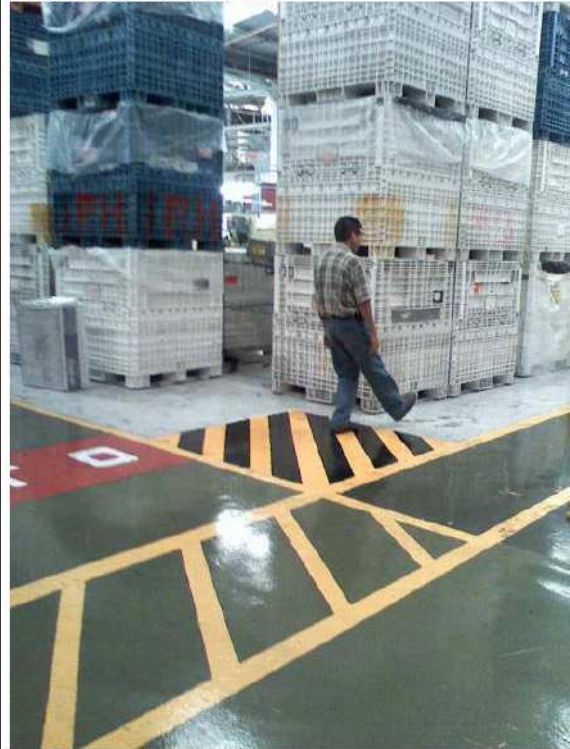
Photo 1: Location of fall

The worker who returned from cafeteria area was walking on vehicular way adjacent to the area of warehouse (market place) and short road walking on a freshly painted area not watching this condition sliding and dropping the same level on her back with impact in the back, hip and left arm

Reinforce training PMHV for pedestrians.

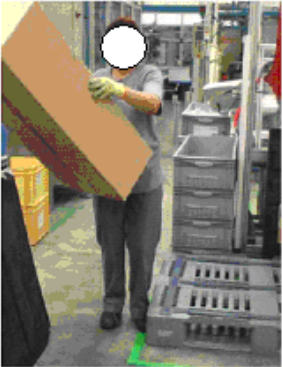
<p><u>Date & Time of Injury:</u> 09/22/2008 at 12.30pm</p> <p><u>Incident Description:</u></p> <p>The operator was working on the non cadency workplace station of the moulding machine area This workplace station is composed of value added operation on parts but is not placed at the exit of the moulding machine. She went at the moulding machine N°8 to take a cardboard with parts to put it on her workplace. During the trip by step she hurts a plastic pallet that was on the floor (in the correct place) and she felt on the floor on her left arm.</p> <p><u>Additional information:</u></p> <ul style="list-style-type: none"> ☞ witness (Y/N): - Yes ☞ supervisor informed, when: - Immediately ☞ Flag: first time or repetitive disorder: ☞ Injury Type: - Fracture ☞ Affected Body Part: - Left elbow ☞ Estimated lost days: - 10 days <p>The pallet was on the floor correctly placed. Housekeeping was OK.</p> <p><u>Root Cause</u></p> <p>Flag: Environmental / Safety / Ergonomic / Fire / Occup. diseases</p> <ul style="list-style-type: none"> - Lack of visibility (cardboard on the arms) - Non using of the equipment in place to transport the carboards <p><u>Interim Corrective Action:</u></p> <ul style="list-style-type: none"> - Communication to the operators on the accident and equipment to use <p><u>Permanent Corrective Action:</u></p> <ul style="list-style-type: none"> - EHS instruction at the workplace station on going for this workplace station : included the using of equipment for transport 	<p>Photo 1: Accident situation</p>

<p><u>Relevant EH&S Standard</u></p> <ul style="list-style-type: none"> ☞ <u>Standard:</u> ☞ <u>Gap to Standard (Y/N):</u> - No ☞ <u>Safety Violation (Y/N):</u> - No 	<p><u>Key Learning Points</u></p> <ul style="list-style-type: none"> ☞ Check in all the EHS instructions placed on the workplace stations for transport of conditioning unit

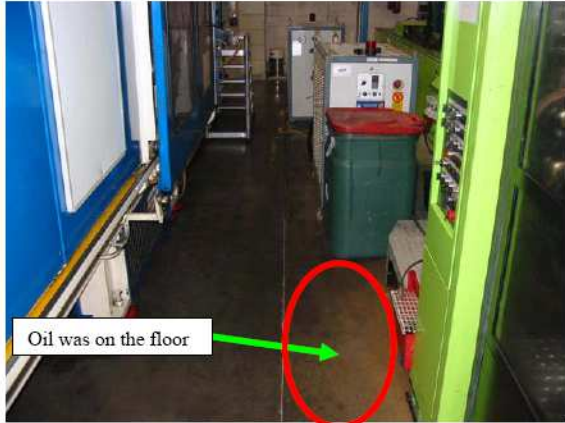
<p><u>Date & Time of Injury:</u> 09/01/08 AM</p> <p><u>Incident Description:</u></p> <p><i>The operator would like to clean oil on the floor. She would like to go through the oil to take a rag and she slept on it.</i></p> <p><u>Additional information:</u></p> <ul style="list-style-type: none"> ➤ Injury Type: -muscular injury ➤ Affected Body Part: - leg ➤ Estimated lost days: - 4 <p><u>Root Cause</u></p> <p><i>Oil on the floor</i></p> <p><u>Interim Corrective Action:</u></p> <p><i>Clean the floor Contain the oil.</i></p> <p><u>Permanent Corrective Action:</u></p> <p><i>Responsabilisation of the management regarding the safety.</i></p> <p><i>The plant manager meet the top management immediately. Such accidents involve the management of the area so the management must be more proactive on safety matters. If safety standards are not achieved, discipline measures will be taken against the management.</i></p>	<p>Photo 1: accident</p>

<p><u>Relevant EH&S Standard</u></p> <p>Responsabilisation of the management.</p> <p>Daily safety walk.</p>	<p><u>Key Learning Points</u></p> <p>Coordination with maintenance in order to repaire or contain immediately the oil (interim corrective action).</p>
